6th Generation Intel® Processor Family

Specification Update

Supporting 6th Generation Intel® Core™ Processor Families based on the H-Processor, S-Processor and Intel® Pentium® Processor

April 2017

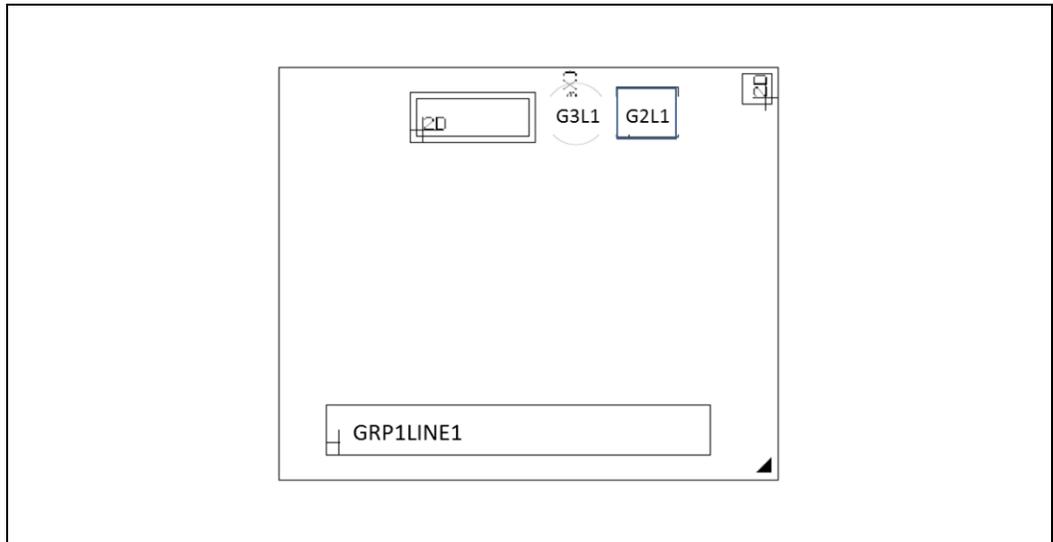
Figure 1. Y-Processor Line BGA Top-Side Markings

Pin Count: 1515

Package Size: 20 mm x 16.5 mm

GRP1LINE1: FPOxxxxxSSPEC
GRP2LINE1 (G2L1): Intel logo
GRP3LINE1 (G3L1): {eX}

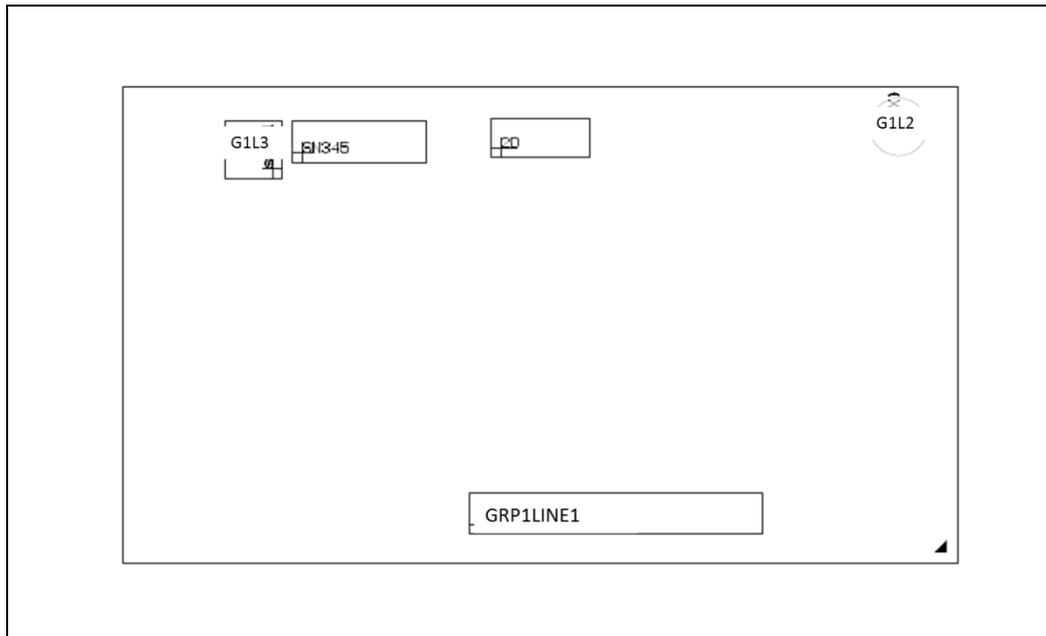
Figure 2. U-Processor Line BGA Top-Side Markings

Pin Count: 1356

Package Size: 42 mm x 24 mm

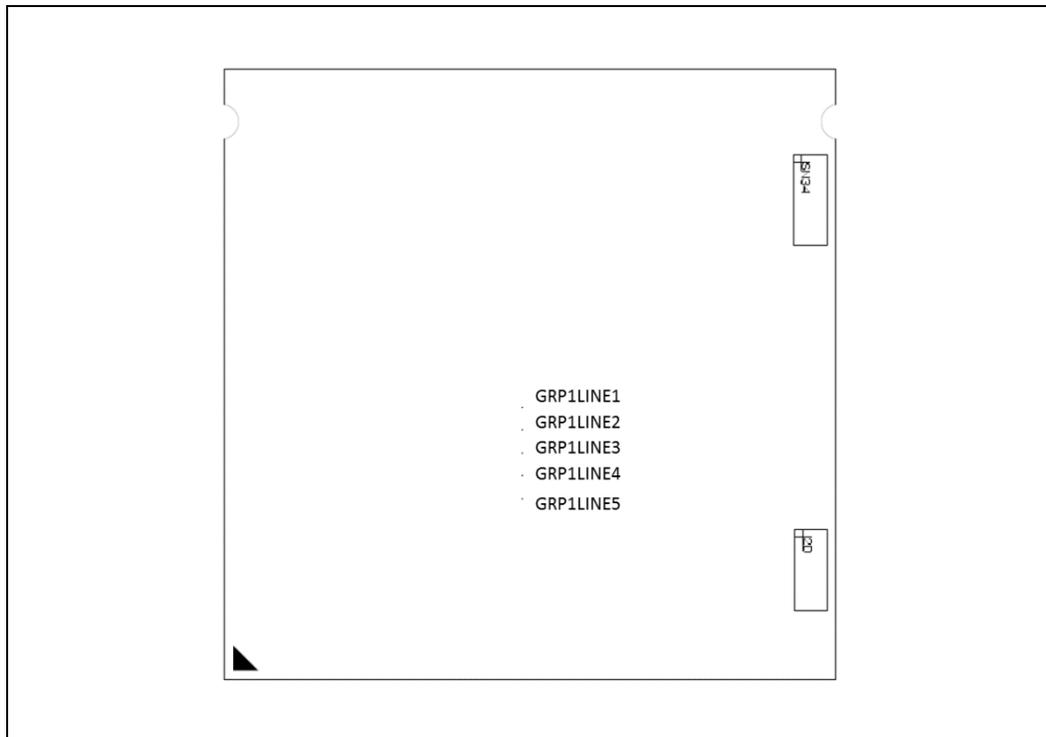
Figure 3. S-Processor Line LGA Top-Side Markings

Pin Count: 1151

Package Size: 37.5 mm x 37.5 mm

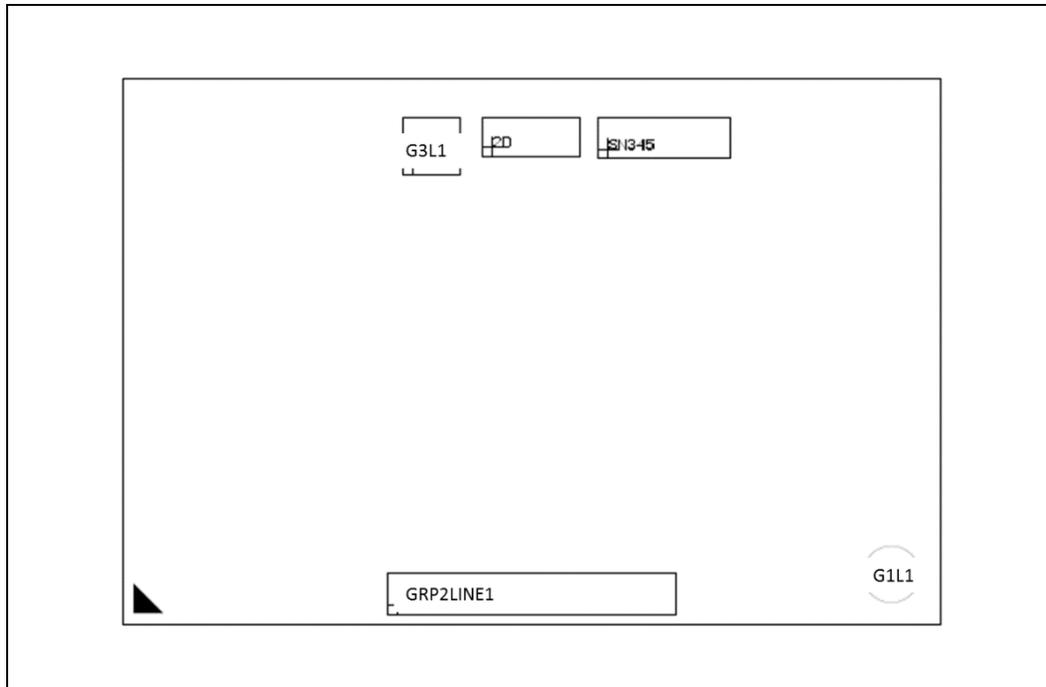
Figure 4. H-Processor Line BGA Top-Side Markings

Pin Count: 1440

Package Size: 42 mm x 28 mm
